New Start Inspections Corp.  
1234 Company Lane  
Somewhere, US 12345  
Indiana License # HI00600219

# Home Inspection Report

123 Somewhere Street  
Yourtown, US 12345

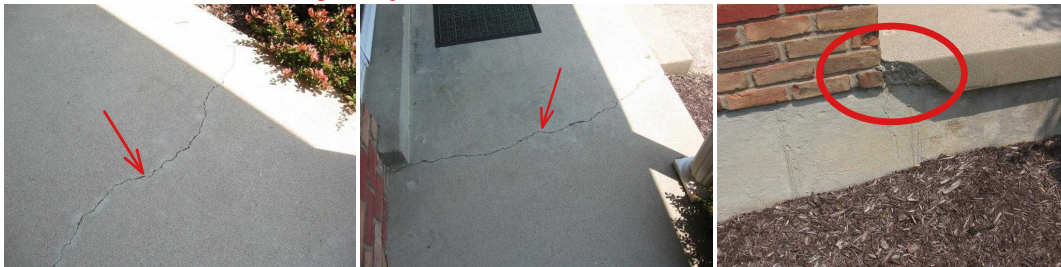
3. Defective Porch: Concrete - Settling away from foundation with surface cracks noted

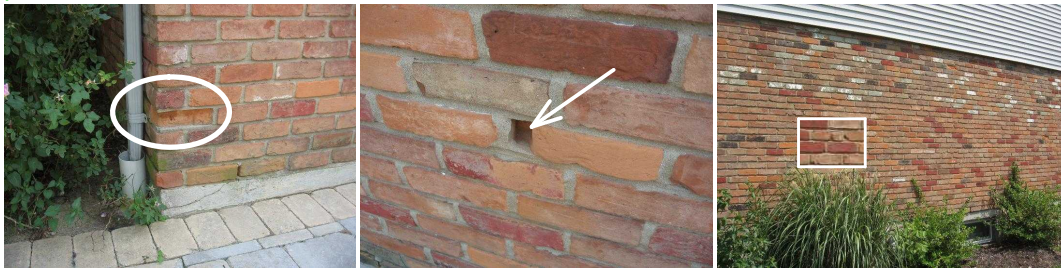
1. Marginal Type: Brick veneer - **Some damaged bricks, Recommend sealing brick with penetration sealer products**

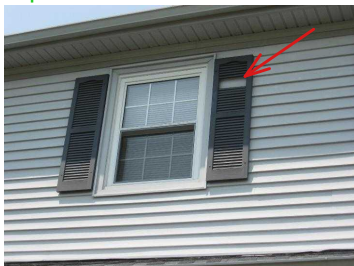
2. Marginal Type: Vinyl siding - **Damaged front shutter, Chalking noted due to age, One panel needs to be repositioned at rear elevation**

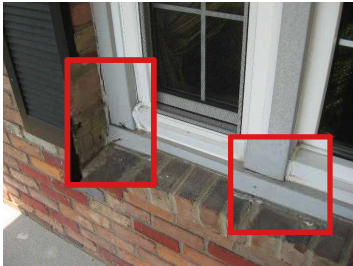
Windows: Vinyl insulated - Reseal caulking at window perimeters at brick window openings

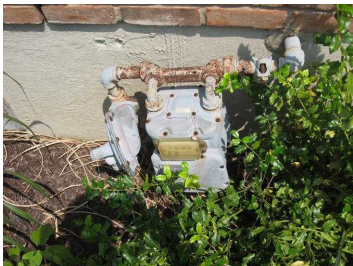
Gas Meter: Exterior surface mount at side of home - Rust present, Keep bushes and shrubs away from meter

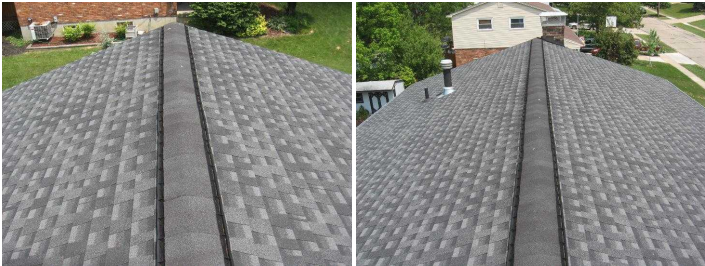
1. Method of Inspection: On roof

- 2. Acceptable      Unable to Inspect: 0%
- 3. Acceptable      Material: Fiberglass shingle
- 4. Type: Gable
- 5. Approximate Age: 5
- 6. Acceptable      Flashing: Metal
- 7. Acceptable      Plumbing Vents: Copper
- 8. Acceptable      Electrical Mast: Underground utilities
- 9. Marginal      Gutters: Aluminum - **Loose nails, Sagging gutters at front and rear**

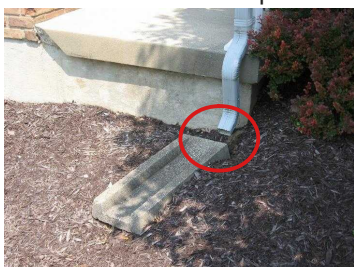
- 10. Acceptable      Downspouts: Aluminum
- 11. Marginal      Leader/Extension: Splash blocks - **Splash block(s) not properly installed**

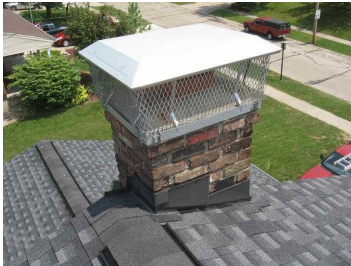
13. Not Inspected Flue/Flue Cap: Clay tile - Weather cap obstructed view of flue

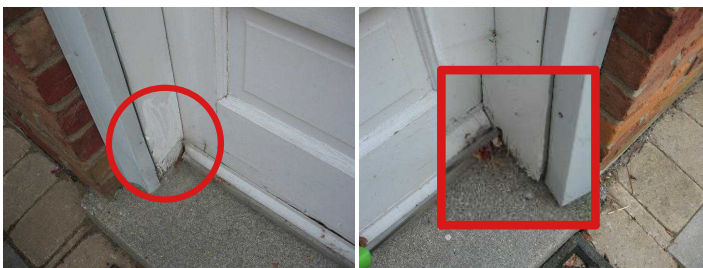
1. Type of Structure: Attached Car Spaces: 2
2. Acceptable Garage Doors: Insulated aluminum
3. Acceptable Door Operation: Mechanized
4. Acceptable Door Opener: Overhead Door
5. Acceptable Exterior Surface: Brick veneer
6. Acceptable Roof: Asphalt shingle
7. Acceptable Roof Structure: 2x6 Rafter
8. Defective Service Doors: Wood - **Wood rot at bottom of door and frame**

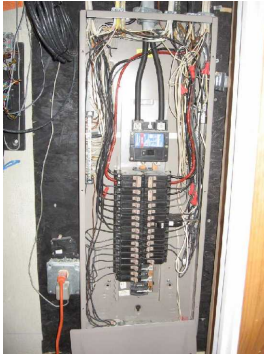
9. Acceptable      Manufacturer: Cutler-Hammer

10. Maximum Capacity: 200 Amps  
11. Acceptable      Main Breaker Size: 200 Amps  
12. Acceptable      Breakers: Copper  
13. Acceptable      AFCI: 110 volt  
14. Acceptable      GFCI: Present  
15. Is the panel bonded? Yes

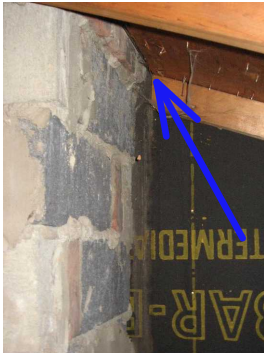
1. Method of Inspection: In the attic  
2. Acceptable      Unable to Inspect: 15% - Safety and footing  
3. Marginal      Roof Framing: 2x3/4 Truss - Wood blocking components missing at chimney perimeter

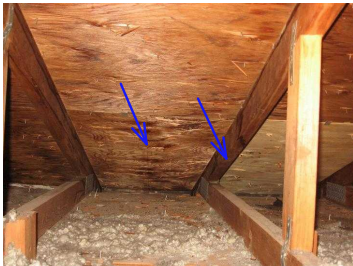
Sheathing: Plywood - Water stains and slight damage present, Areas of sheathing have been repaired

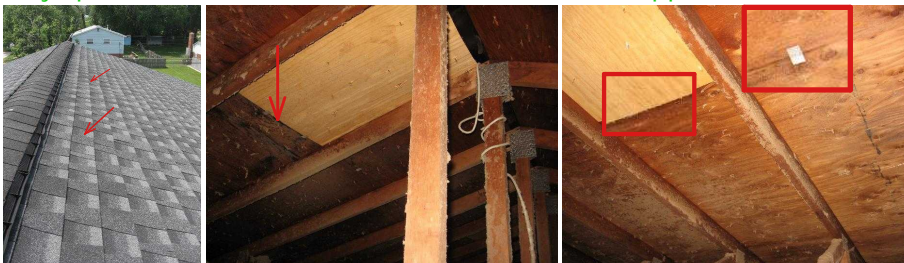
Sheathing: Plywood - Poor repair at 2 areas near ridge at rear slope - No H clips installed and repair only spanned one truss - Recommend additional support be installed

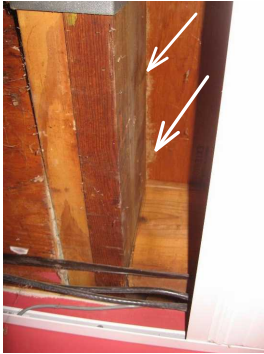
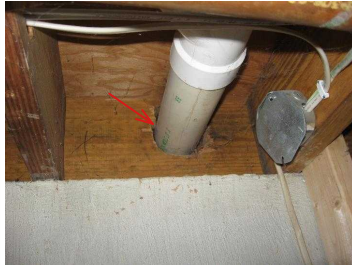
1. Acceptable      Structure Type: Wood frame
2. Acceptable      Foundation: Poured concrete
3. Acceptable      Differential Movement: Slight settlement present - Minor settlement at front porch, Cracks will require monitoring
4. Acceptable      Beams: Steel I-Beam
5. Acceptable      Bearing Walls: Wood frame
6. Marginal      Joists/Trusses: 2x10 - Areas not visible due to ceiling finishes or other obstructions, Framing joist near fireplace chimney shows evidence of previous termite infestation - No repairs required, Seal penetration as required

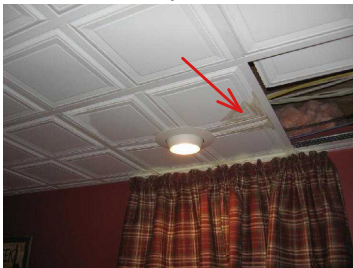
1. Acceptable Unable to Inspect: 0%

2. Acceptable Ceiling: Suspended Acoustical System - Evidence of past water staining

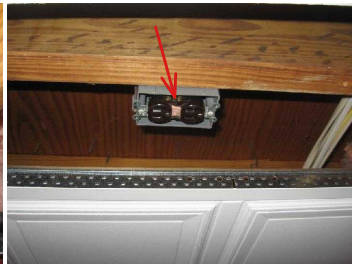
8. Marginal Electrical: 110 VAC - **Loose junction boxes, missing and mis-sized covers, extension cord wiring to projector**

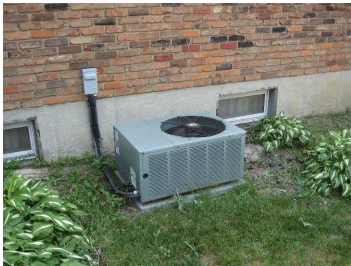
1. Acceptable A/C System Operation: Appears serviceable
2. Acceptable Condensate Removal: Plastic tubing
3. Acceptable Exterior Unit: Pad mounted

4. Manufacturer: Rheem
5. Area Served: Whole house Approximate Age: 7
6. Fuel Type: 110 VAC Temperature Differential: 16 degrees
7. Type: Central A/C Capacity: 3 Ton
8. Acceptable Visible Coil: Copper core with aluminum fins
9. Acceptable Refrigerant Lines: Serviceable condition
10. Acceptable Electrical Disconnect: Breaker disconnect
11. Acceptable Exposed Ductwork: Metal
12. Acceptable Blower Fan/Filters: Direct drive with electronic filter
13. Acceptable Thermostats: Single Zone

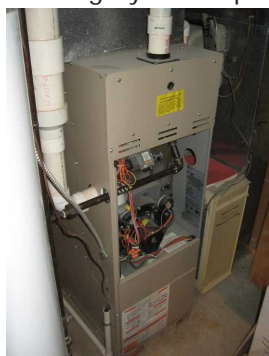
1. Acceptable Heating System Operation: Appears functional

2. Manufacturer: Ducane

3. Type: Forced air Capacity: 100,000 BTUHR

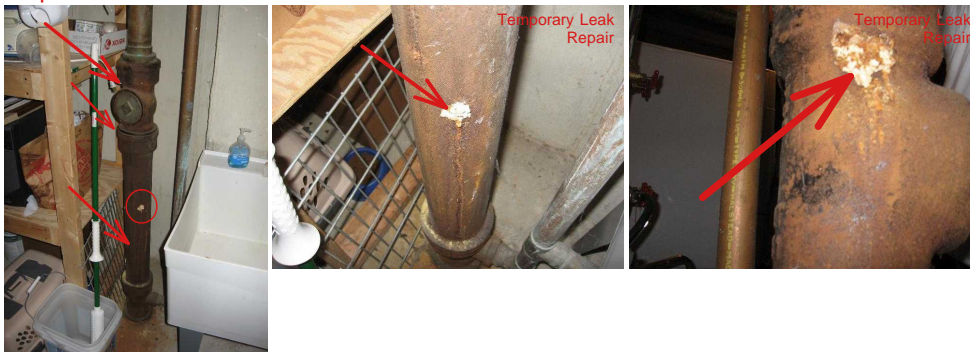
1. Acceptable Service Line: Copper
2. Acceptable Main Water Shutoff: Basement
3. Acceptable Water Lines: Copper
4. Defective Drain Pipes: Cast iron, Copper - **Pitting cast iron drain piping stack - replace affected sections where required**

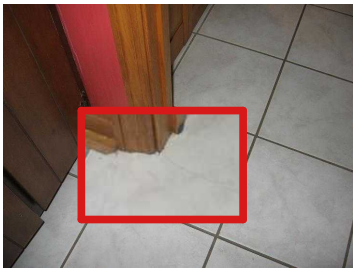
30. Marginal Floor: Ceramic tile - Cracked tile noted

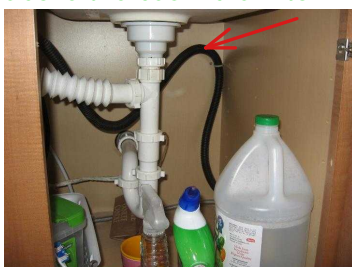
- 1. Acceptable Cooking Appliances: Frigidaire
- 2. Acceptable Disposal: General Electric
- 3. Marginal Dishwasher: Maytag - Properly secure the dishwasher discharge hose so that it creates a "high loop" above the basin drain to minimize food or water backup under dishwasher

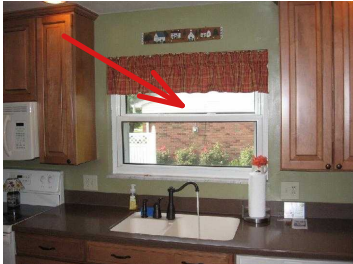
- 4. Air Gap Present? No
- 5. Acceptable Refrigerator: Amana
- 6. Acceptable Microwave: General Electric
- 7. Marginal Sink: Stainless Steel - **Chipping at drain**
- 8. Acceptable Electrical: 110 VAC GFCI
- 9. Acceptable Plumbing/Fixtures: Stainless Steel
- 10. Acceptable Counter Tops: Solid Surface
- 11. Acceptable Cabinets: Wood - Loose cabinet door hinges
- 12. Acceptable Pantry: Large
- 13. Acceptable Ceiling: Drywall
- 14. Acceptable Walls: Drywall
- 15. Acceptable Floor: Ceramic tile
- 16. Acceptable Doors: Hollow wood
- 17. Defective Windows: Vinyl Insulated - **Insulated glass unit seal failure**

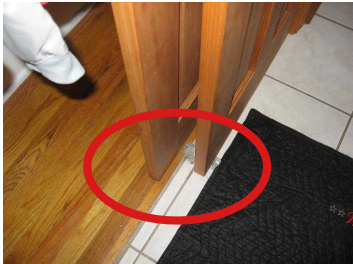
Closet: Various - **Missing door glides at bypass closet door in Foyer**

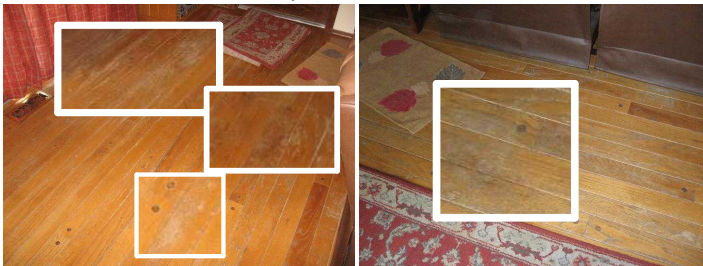
Floor: Ceramic tile, Carpet, Hardwood - **Worn wood finish in Family room**

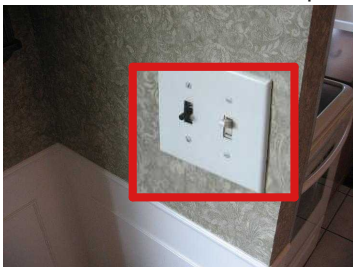
Electrical: 110 VAC - Replace missing dimmer switch in Dining room

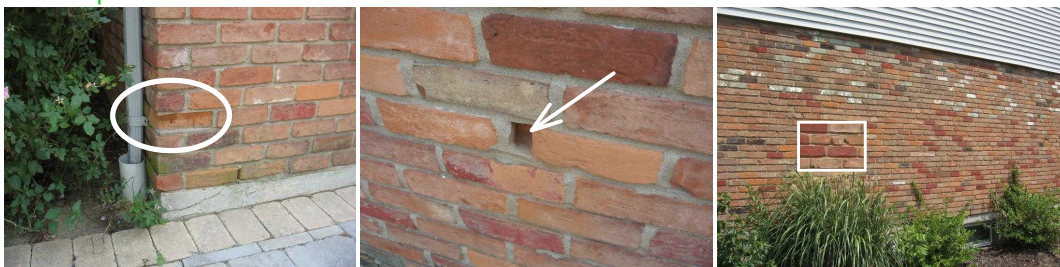
2. 1st Floor Exterior Surface Type: Brick veneer - Some damaged bricks, Recommend sealing brick with penetration sealer products

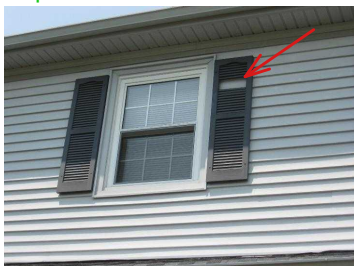
3. 2nd Floor Exterior Surface Type: Vinyl siding - Damaged front shutter, Chalking noted due to age, One panel needs to be repositioned at rear elevation

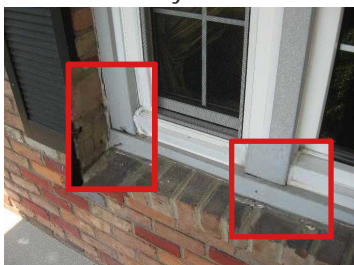
4. Trim: Aluminum - Chalking noted due to age, Loose nails in areas
5. Soffits: Vinyl - Loose/sagging at front porch
6. Patio Door: Vinyl sliding - Resecure loose handle hardware, Screen damage noted
7. Windows: Vinyl insulated - Reseal caulking at window perimeters at brick window openings

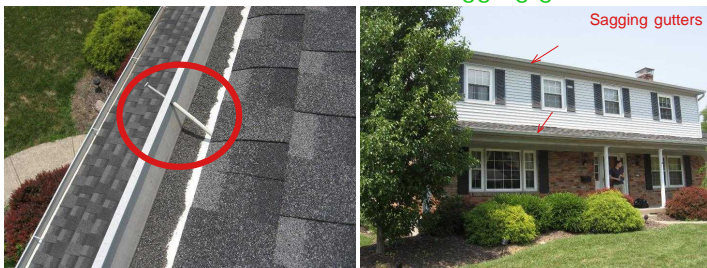
9. Gutters: Aluminum - Loose nails, Sagging gutters at front and rear

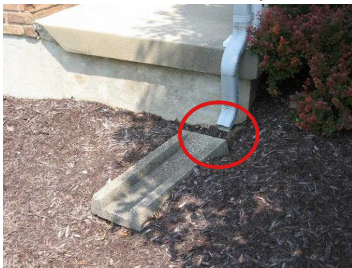
10. Leader/Extension: Splash blocks - Splash block(s) not properly installed

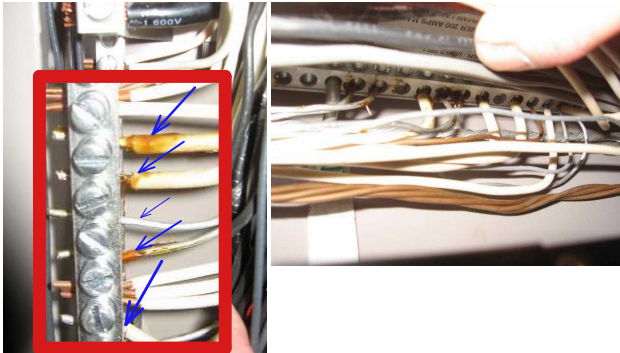
14. 120 VAC Branch Circuits: Copper and aluminum - Evaluation by a licensed electrician is recommended, See aluminum wiring notes below  
15. Aluminum Wiring: Present at several circuits - Aluminum branch wiring has had a history of problems relating to poor connections due to galvanic corrosion, dissimilar metals, brittle conductors and type of aluminum alloy used during the time period of 1965 through 1972. These problems create unsatisfactory conditions at connections and splice locations and therefore create potential fire hazards. Recommend wiring update for aluminum wiring by a licensed electrician, Circuits are recommended to be upgraded with special compression type connectors at splices and branch circuits to reduce the potential risks of aluminum branch wiring.(Cop-Alum Crimp System)

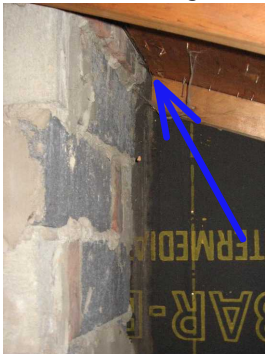
16. Attached Garage Attic Roof Framing: 2x3/4 Truss - Wood blocking components missing at chimney perimeter

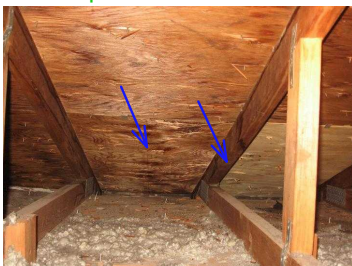
17. Attached Garage Attic Sheathing: Plywood - Water stains and slight damage present, Areas of sheathing have been repaired

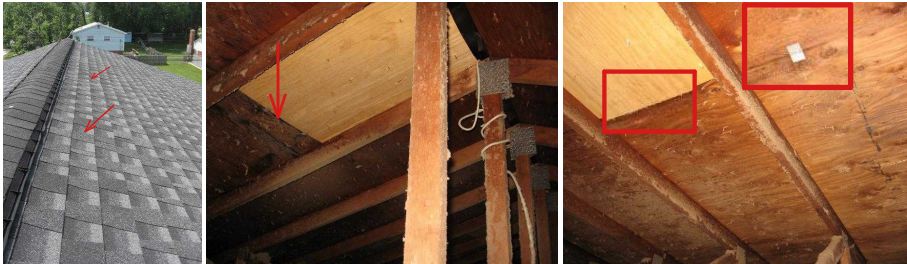
18. Main Attic Sheathing: Plywood - Poor repair at 2 areas near ridge at rear slope - No H clips installed and repair only spanned one truss - Recommend additional support be installed

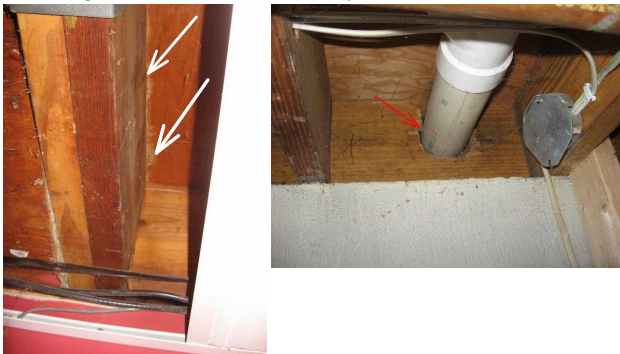
19. Joists/Trusses: 2x10 - Areas not visible due to ceiling finishes or other obstructions, Framing joist near fireplace chimney shows evidence of previous termite infestation - No repairs required, Seal penetration as required

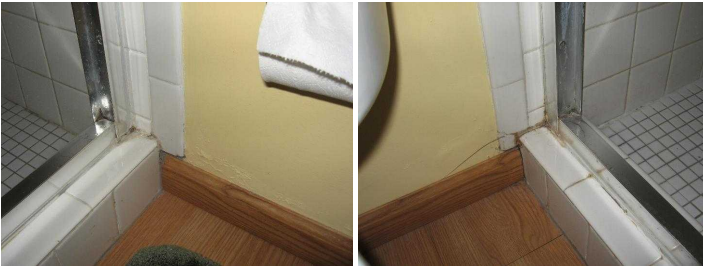
22. Master Bathroom Floor: Laminated flooring - Gapping noted in planks  
23. Master Bathroom Shower/Surround: Ceramic tile - Leaking at corner of door frame

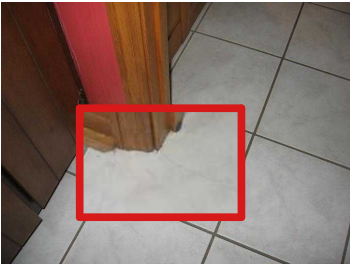
- 24. 2nd Floor Hall Bathroom Closet: Large - Alignment needed at closet doors
- 25. 2nd Floor Hall Bathroom Floor: Laminated flooring - Gapping noted in planks
- 26. 1st Floor Hall Half Bathroom Floor: Ceramic tile - Cracked tile noted

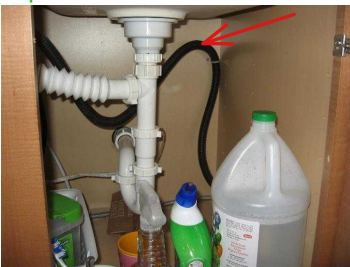
- 27. 1st Floor Kitchen Dishwasher: Maytag - Properly secure the dishwasher discharge hose so that it creates a "high loop" above the basin drain to minimize food or water backup under dishwasher

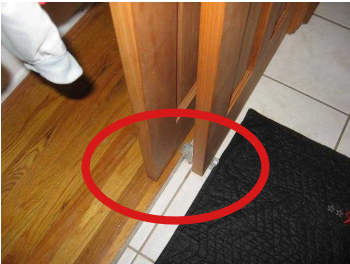
- 29. 1st Floor Living Space Closet: Various - Missing door glides at bypass closet door in Foyer

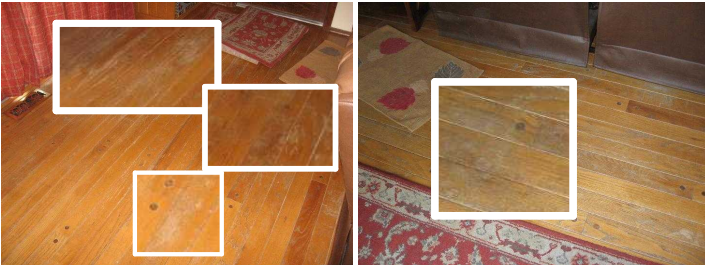
30. 1st Floor Living Space Floor: Ceramic tile, Carpet, Hardwood - Worn wood finish in Family room

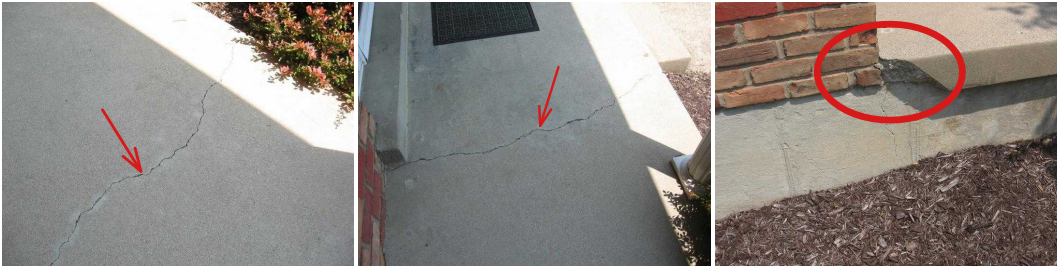
1. Porch: Concrete - Settling away from foundation with surface cracks noted

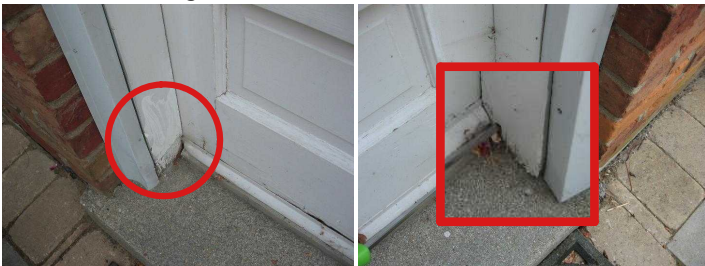
2. Attached Garage Service Doors: Wood - Wood rot at bottom of door and frame

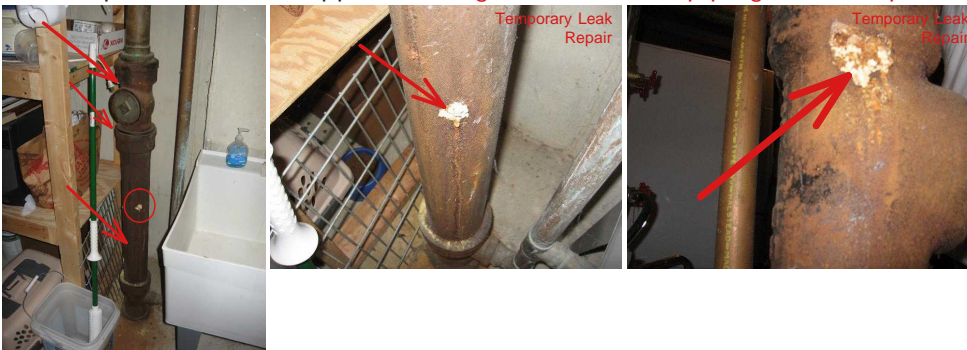
4. Drain Pipes: Cast iron, Copper - Pitting cast iron drain piping stack - replace affected sections where required

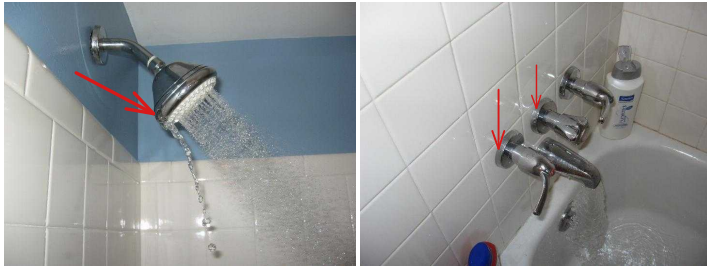
5. 2nd Floor Hall Bathroom Faucets/Traps: Delta fixtures with a metal trap - **Leaking shower head, Loose trim rings**

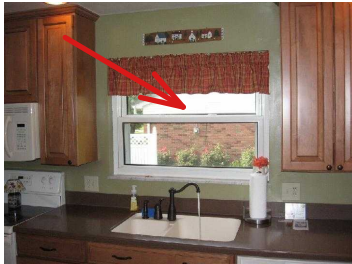
6. 1st Floor Kitchen Windows: Vinyl Insulated - **Insulated glass unit seal failure**
